Manhole Inspection Summary

Manhole # S19G__043MH

Insp Date: **10/1/07 11:25 AM**

Location Address: **32 PULASKI ST**

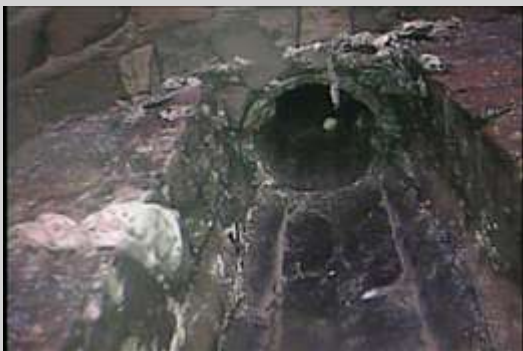
4 O'Clock Inflow

6 in. Circular Gravity Sewer
Pipe In @ 4 O'Clock

Pipe Height: **6** (in.) Rod and Bar (Angled)
Pipe Material: **Clay** ☐ Pipe Lined
Invert Depth: **8.00** (ft.) Flow Characteristics: **Slow**
Deposits: ☒ **None** ☐ Mud ☐ Sludge ☐ Debris ☐ Grease
Silt Depth: (in.) Deposits Extent:
Infiltration: **None** Pipe Seal Cond: **Sound**

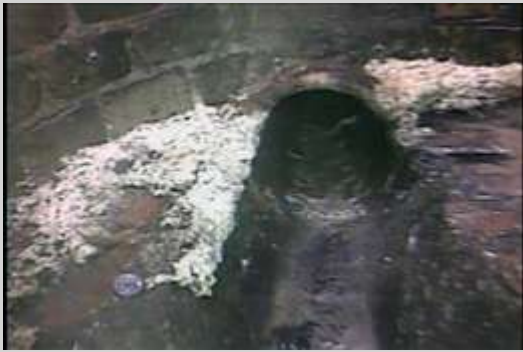
8 O'Clock Inflow

6 in. Circular Gravity Sewer

Pipe In @ 8 O'Clock

Pipe Height: **6** (in.) Rod and Bar (Angled)

Pipe Material: **Clay** ☐ Pipe Lined

Infiltration: **None**
